# **Ecological Appraisal**

## **Storage shed**

### **West Rainton Cemetery**

**Gary Shears  
Ecology Section  
Durham County Council  
January 2019**

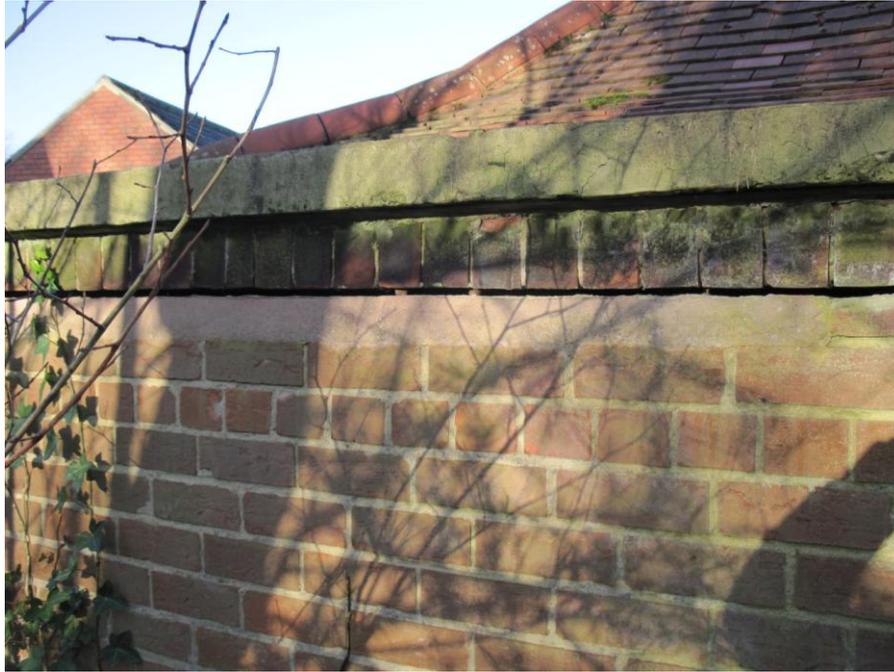
The building contains few opportunities for bat roosting. Gaps were noted in the brickwork between the single brick walls and flat concrete roof (plate 1 below) however when inspected with a torch they were heavily cobwebbed. The entrance doors are tight to the walls.

**Plate 1: gap in brickwork providing access into building**

No signs of bat roosting were found and very few opportunities exist for bats to roost in the building. Foraging habitat is reasonable around the building however as bat roosting opportunity is minimal the risk of encountering bats during the demolition is low.

The building is proposed for demolition however as impacts on the local bat population are negligible it is considered that no further survey work or mitigation is required for bats.

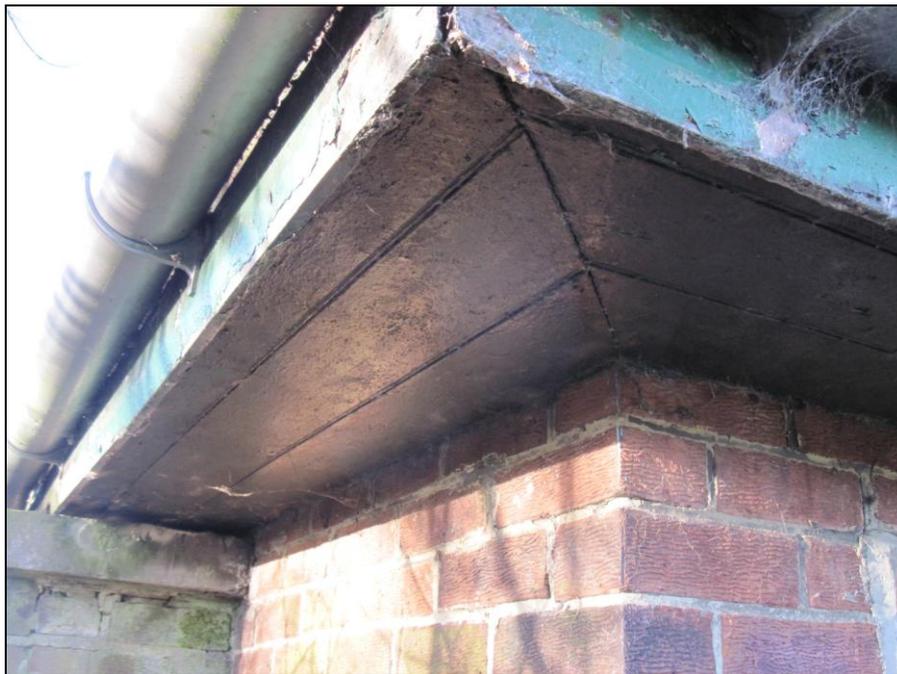
The wooden soffits were mostly tight but where gaps exist they were heavily cobwebbed (plate 2 below). There are no windows.

**Plate 2: heavily cobwebbed soffits**
